5.0 INSPECTION TECHNIQUES AND FAILURE ANALYSES

5.2 DPA Results

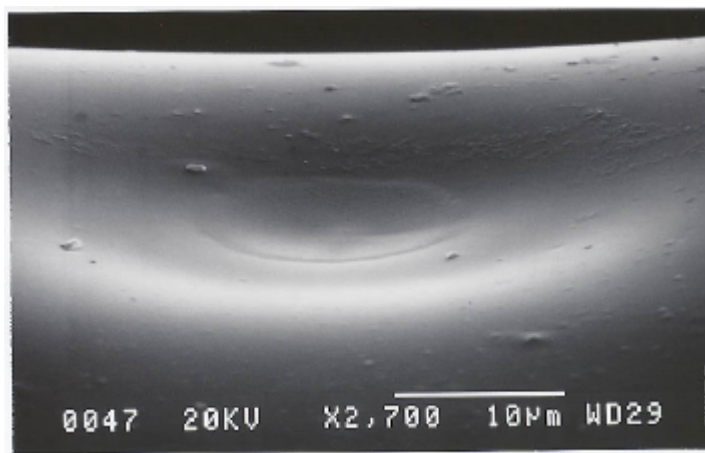
Figure 5 Sink in the Polyimide Coating

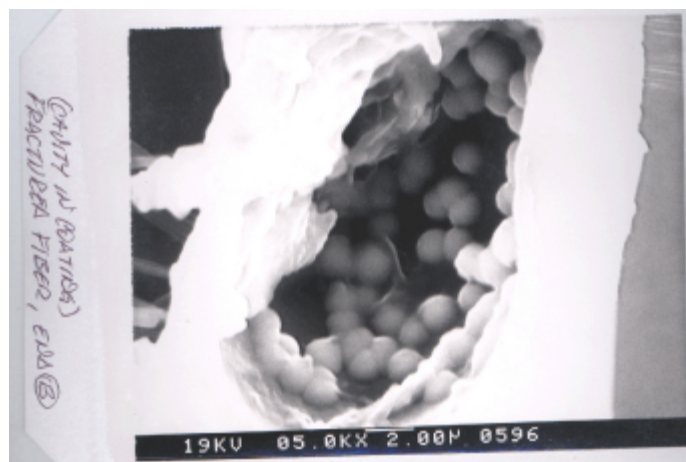
Figure 6 SiO₂ Balls in Polyimide Void

These figures were all produced with a scanning electron microscope. EDX was used to determine the composition of the glass to determine the presence of contamination and to identify the composition of the spheres and crystals found in Figures 6 and 7. Polarized light was used to confirm that the “shards” were indeed crystalline. Optical microscope images are also available but are more difficult to interpret independently.

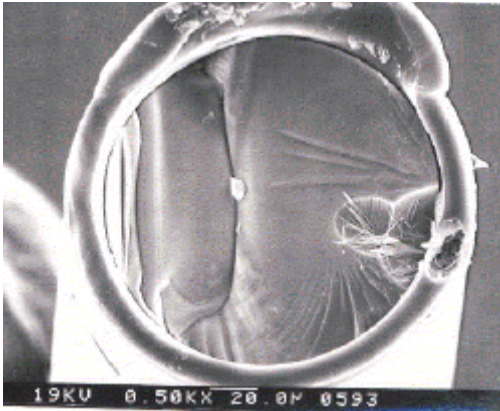
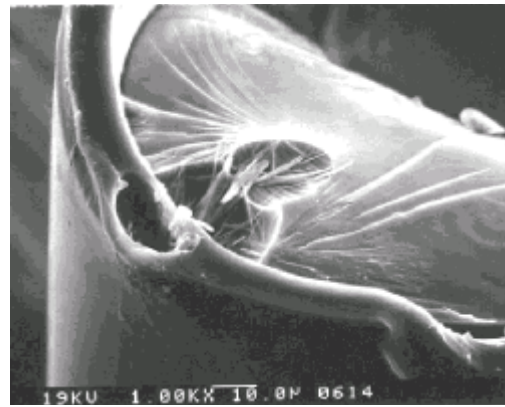
Figure 7 GeO₂ Crystals in Etch Pit

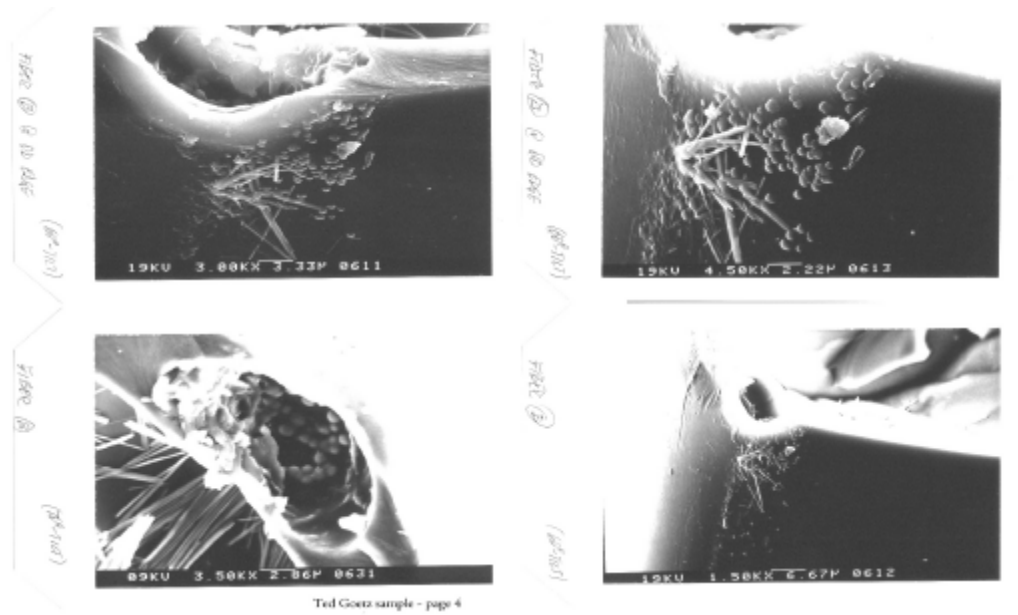
Figure 8 GeO₂ and SiO₂ Debris on Outside of Coating

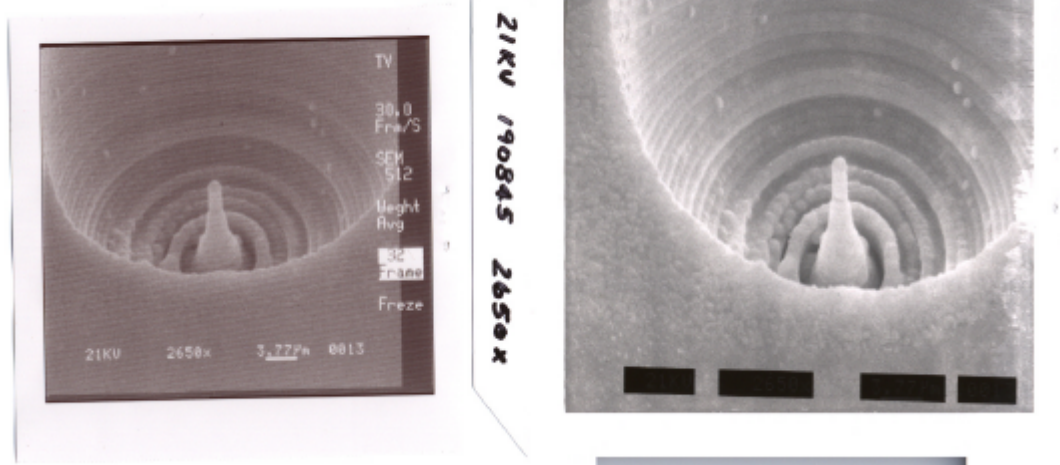
Figure 9 Si-spire in Deep Etch Pit

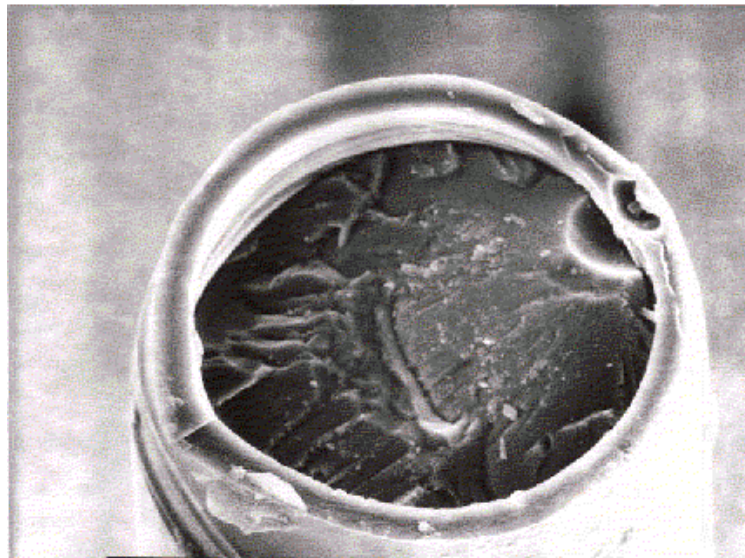
Figure 10 Characteristic Void in Polyimide Above Shallow Etch Pit

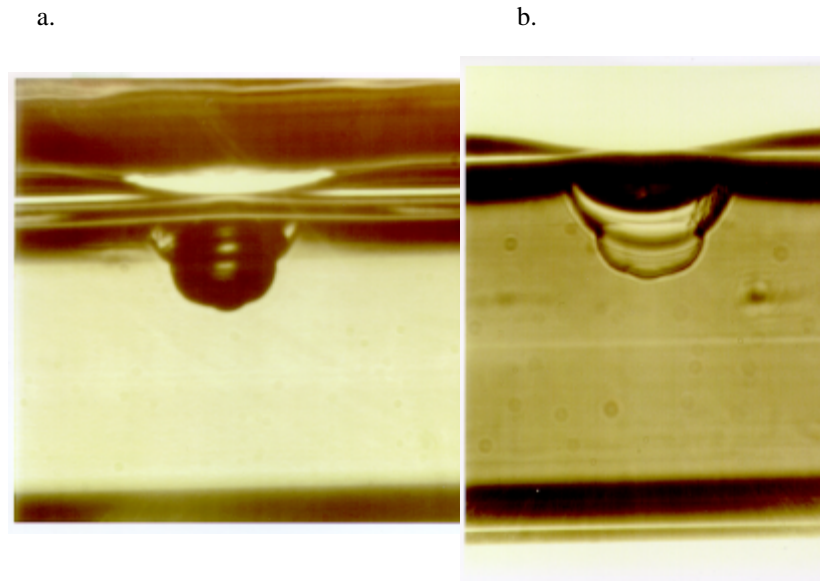
The use of index matching oil and backlighting during imaging was found to greatly enhance the optical microscope images. After submersion of an intact piece of fiber in index matching oil and having left the sample overnight, the oil was found to have filled the “rocket engine” void (Figure 11a and 11b). This indicated that the surface of the “rocket engine” defect was exposed to ambient atmosphere.

Figure 11 Defect Inspection Using Index Matching Oil

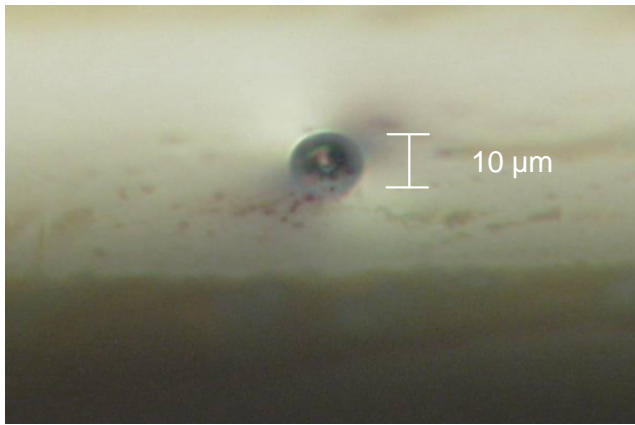
a. OPTICAL

Figure 12 Depressions and Bubble in Polyimide Coating in Fiber CD0588XD

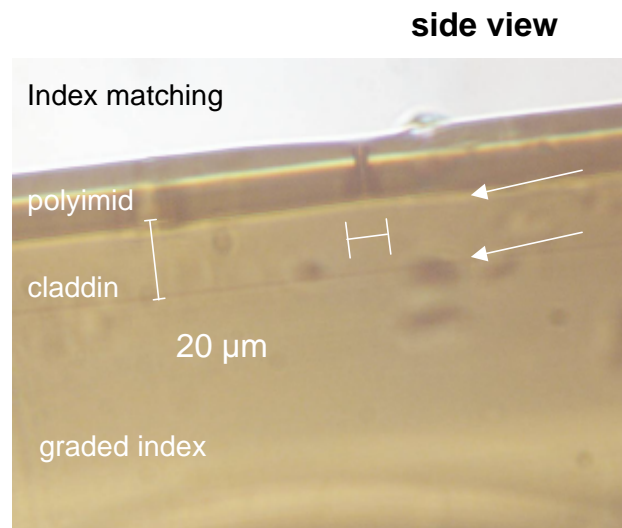
Optical inspection was used to examine the polyimide surface of fiber containing “glows”. Features were found resembling depressions and buried bubbles (Figures 5-8, 10, and 12). Field emission scanning electron microscope (FE-SEM) inspections were also performed on 6” samples from two lots of fiber which had never been cabled by BICC (Figure 13) [ref 8]. The samples were from reels CD0588XD and CD0384XB. Though both lots were found to weaken due to the cabling processes, the CD0588XD fiber was found to be more dramatically weakened than the CD0384XB (see Section 7.0). Sixteen features were found in the polyimide in the “588” sample and one was found in the polyimide in the “384” sample (four more features were found in an additional sample of “588” fiber). An hour glass-like shape was found to be very common among the bubbles observed, as is shown in Figure 13.

Figure 13 Hourglass Shape of Bubble and Polyimide
